**Preliminary Site
Investigation/Detailed Site
Investigation**

6-10 Orr Street, Ashburton

Kāinga Ora Homes and Communities

Tonkin & Taylor Ltd

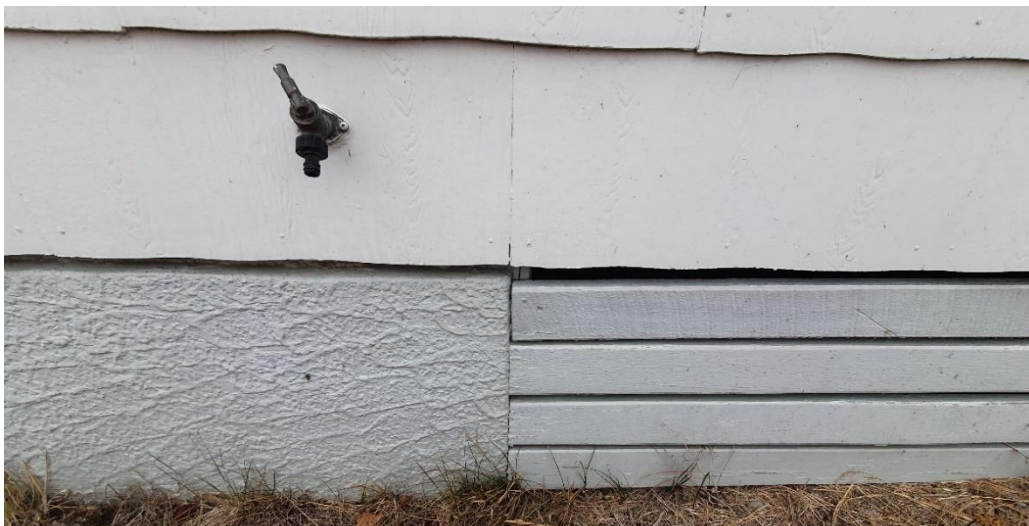
Photograph B5: Cladding and foundation detail including textured (stucco) render, painted timber and duroc cement sheet cladding.

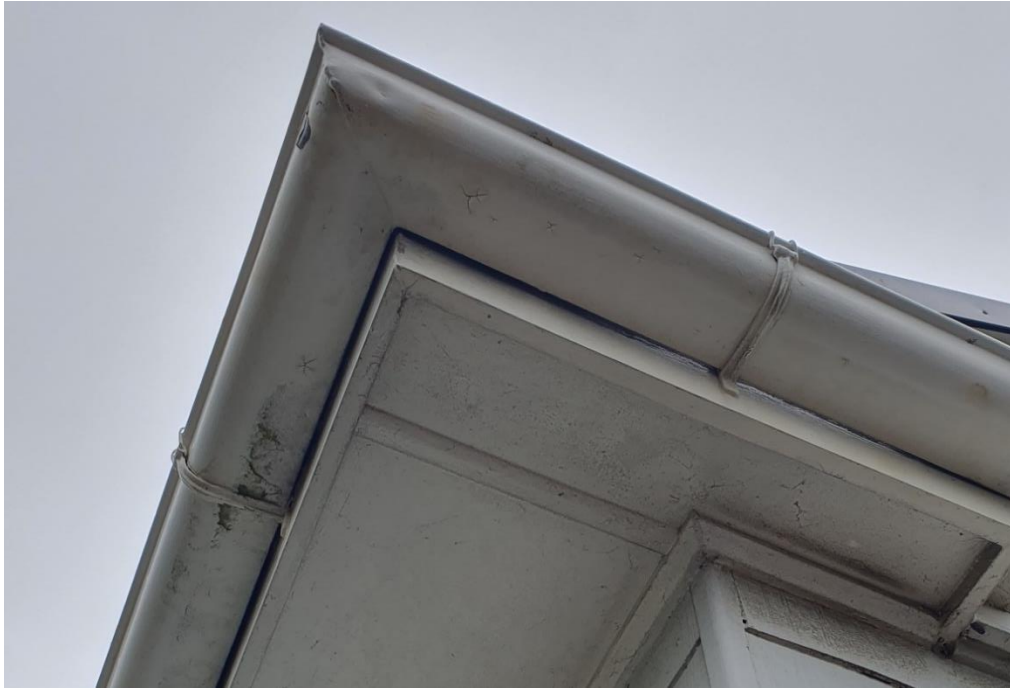
Photograph B6: Soffit and cladding detail.

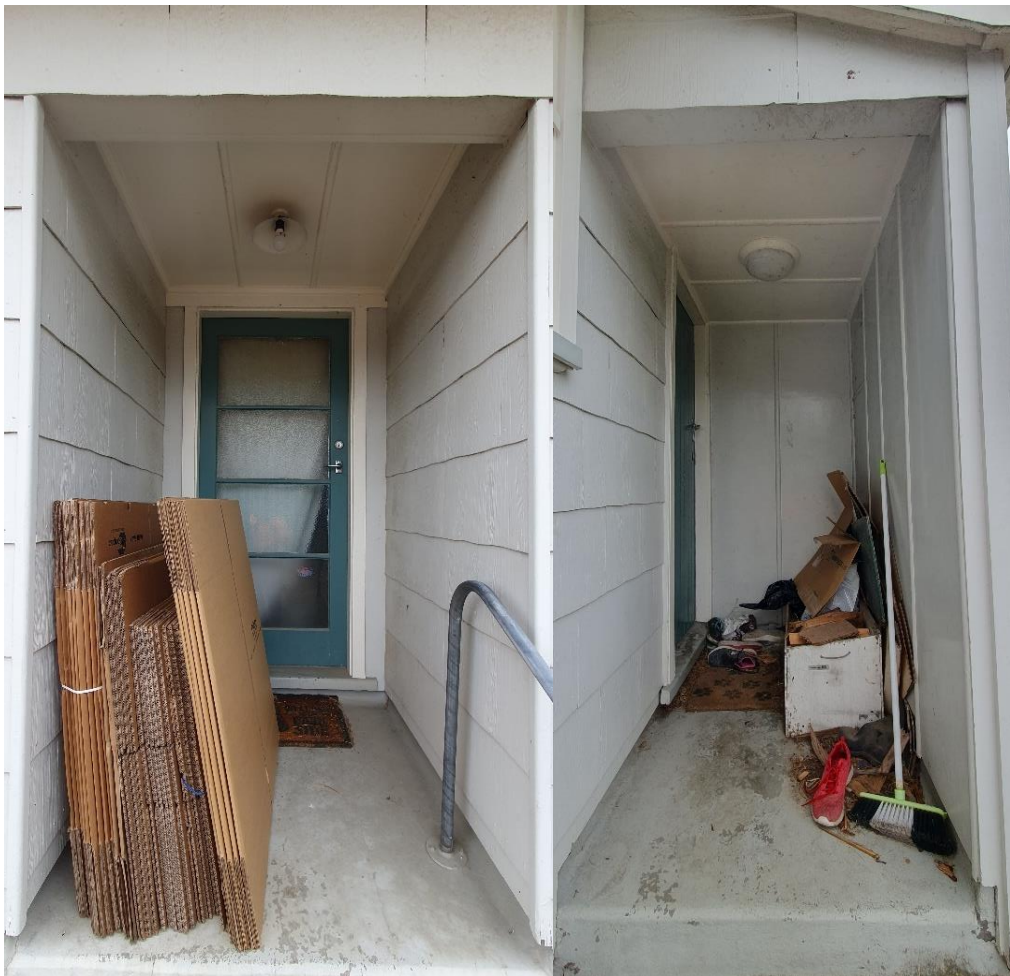
Photograph B7 (left) and B8 (right): Dwelling's front and rear entryways, respectively; PACM walls and ceiling at both.

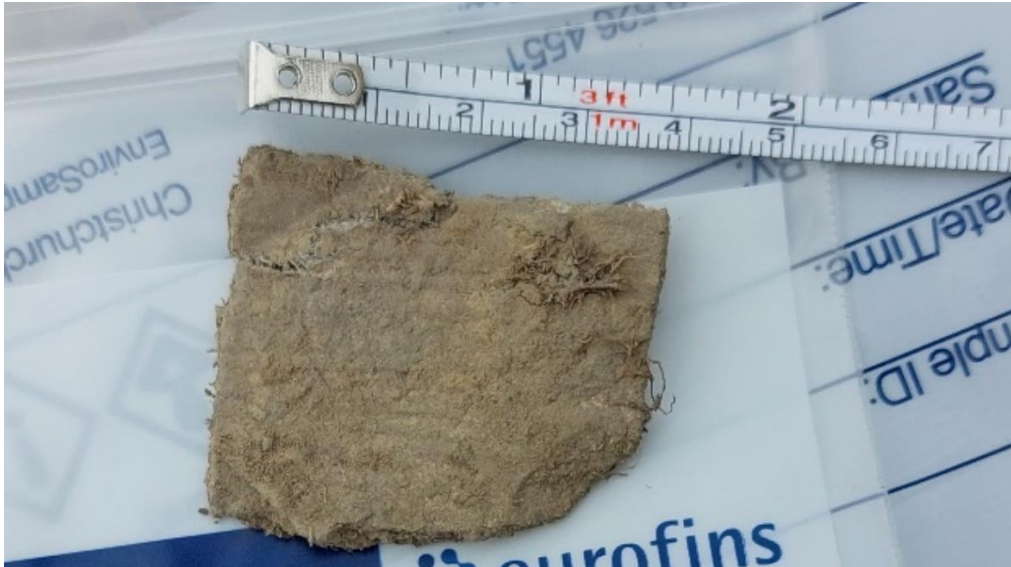
Asbestos was not detected in the soil samples analysed by T+T; however, a fragment of confirmed ACM was found at location 6HA2 and on this basis the Asbestos Regulations do apply to soil disturbance at the site and at this location (see Section 8.2).

Photograph B9: ACM fragment identified in surficial soil (approximately 0.15 m bgl) at 6HA2. Fragment removed from site.

As a fragment of asbestos was found at investigation location 6HA2, soil disturbance work in this area of the site will need to be undertaken in accordance with the Asbestos Regulations and Asbestos in Soil Guidelines. Based on the laboratory data and Asbestos in Soil Guidelines, soil disturbance work in 6HA2 can be undertaken as ***'unlicensed asbestos work'***.

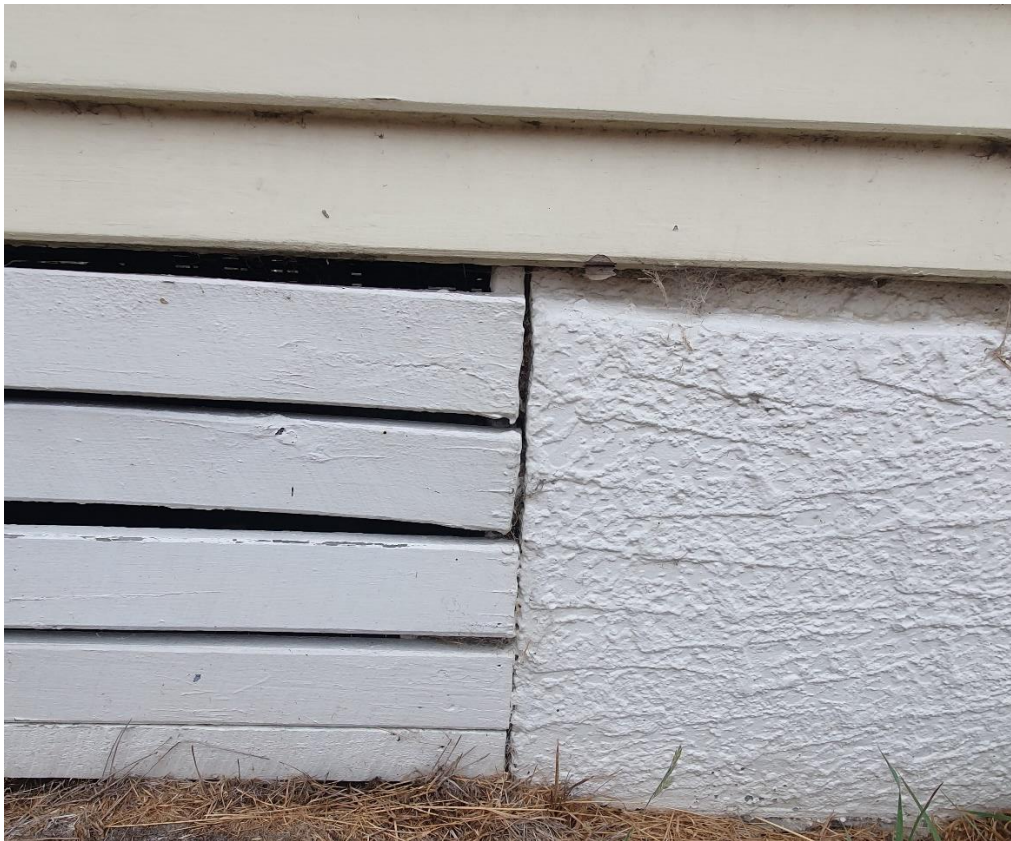
Photograph B16: Cladding and foundation detail including textured (stucco) render, painted timber, and weatherboard cladding.

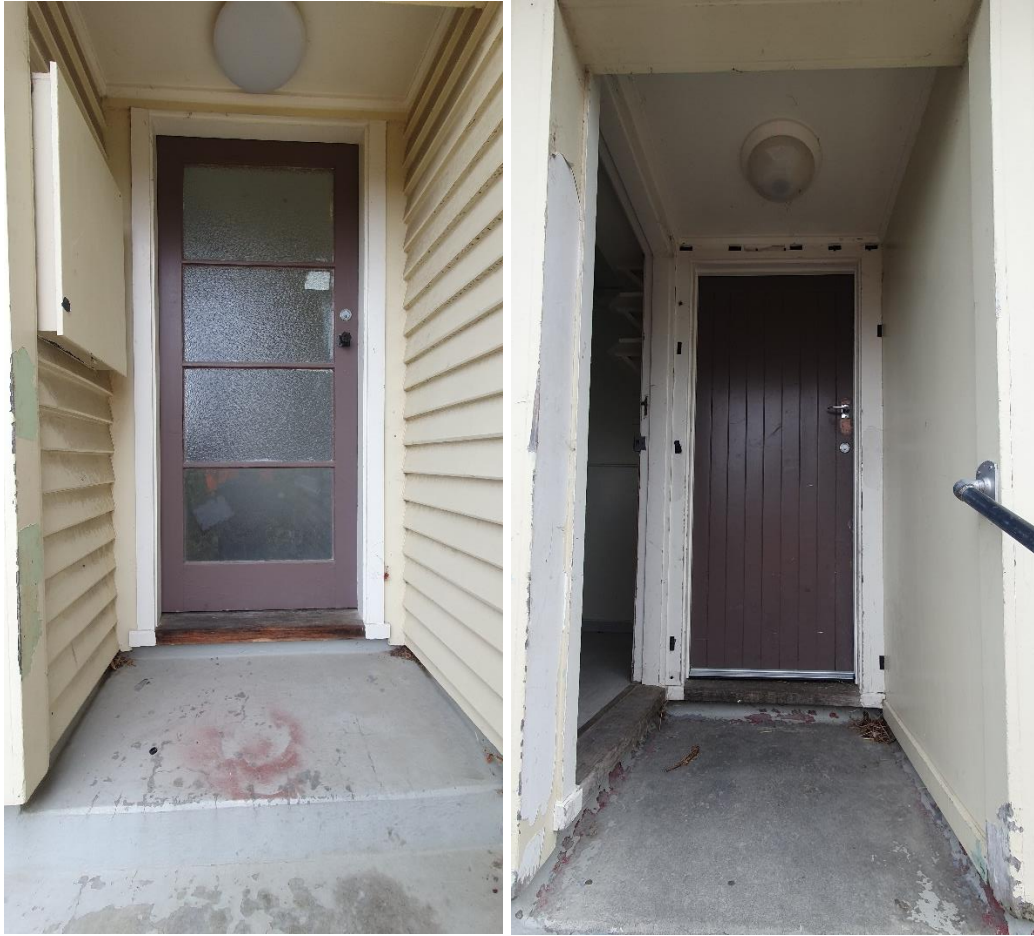
Photograph B17 (left) and B18 (right): Dwelling's front and side entryways, respectively; PACM ceiling and weatherboard walls at front entrance. PACM ceiling and walls at side entrance.

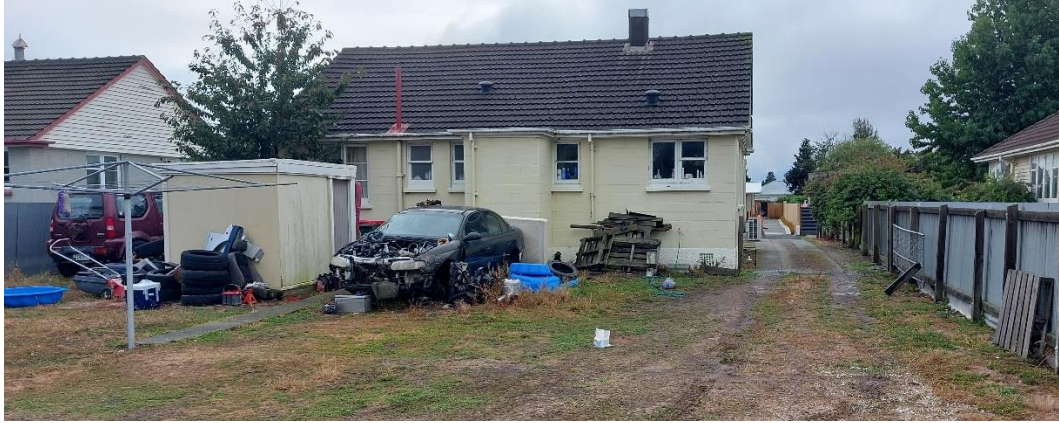
Photograph B20: Rear elevation of dwelling (facing north-east). Note the car and car parts next to shed.

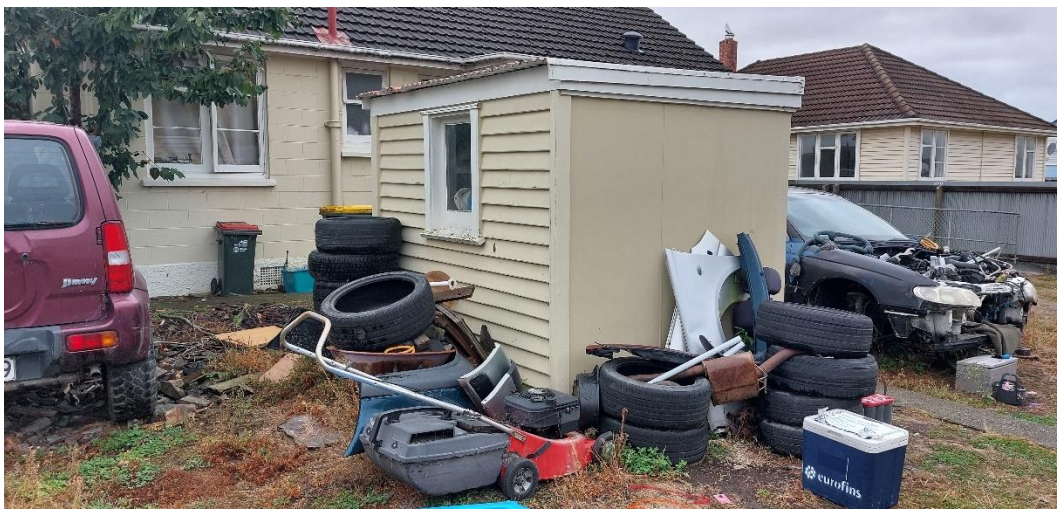
Photograph B21: Shed detail (facing east). Weatherboard and PACM cement sheet cladding. Stockpiled tires and car parts next to shed.

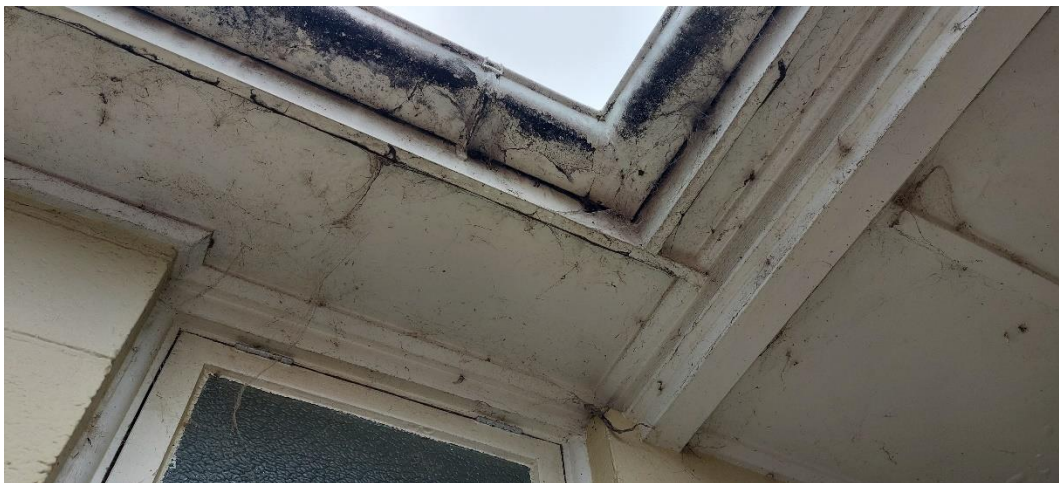
Photograph B22: Soffit detail (PACM cement sheet).

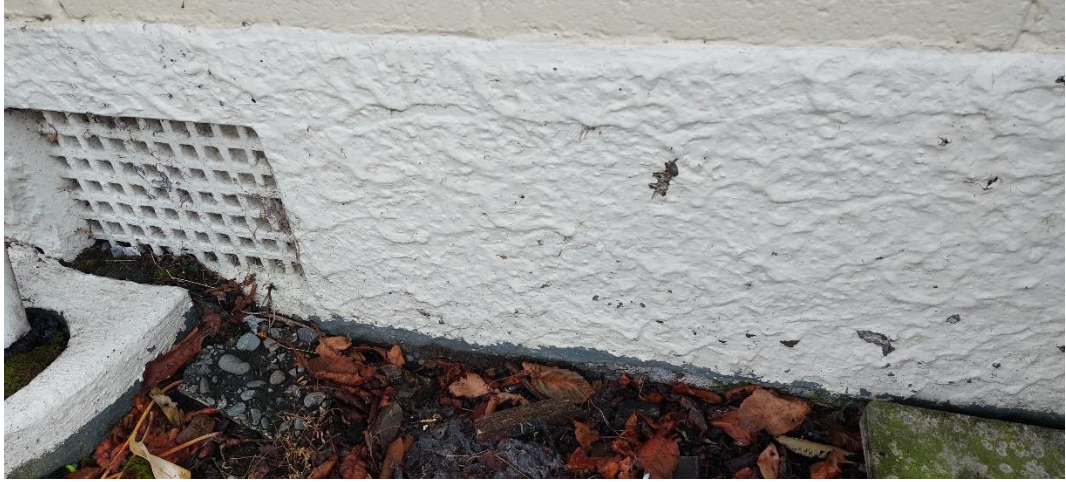
Photograph B23: Dwelling foundation detail (textured PACM (stucco) render).

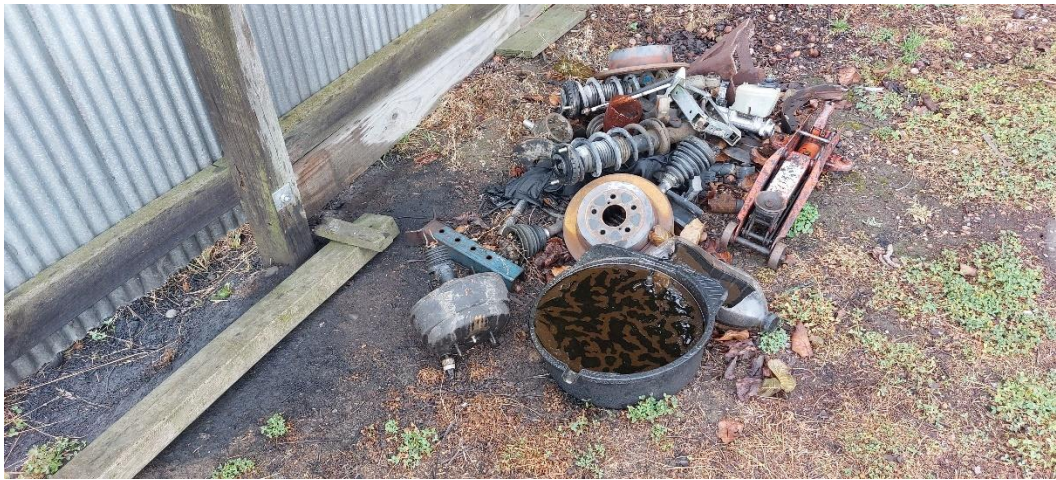
- Two unused cars next to the shed, an oil drain pan (at location 10HA7), and discarded car parts were observed at the backyard of 10 Orr Street (see Section 2.4). Dark oil staining and odour were noted on the ground surface at locations 10 HA3 and 10 HA7. The staining and odour did not penetrate the soil profile (restricted to top 20 mm at 10HA7 and to top 3 mm at 10HA3).

Photograph B24: Investigation 10HA7 location, visible oil staining on soil and car parts present.

- Widespread remediation of the site is not required for the proposed use of the site as high-density residential housing. The planned site scrape and offsite disposal of soils from ground level to 0.4 m bgl will remove soils where a fragment of asbestos was found and where arsenic and lead have been recorded above high-density residential land use criteria.

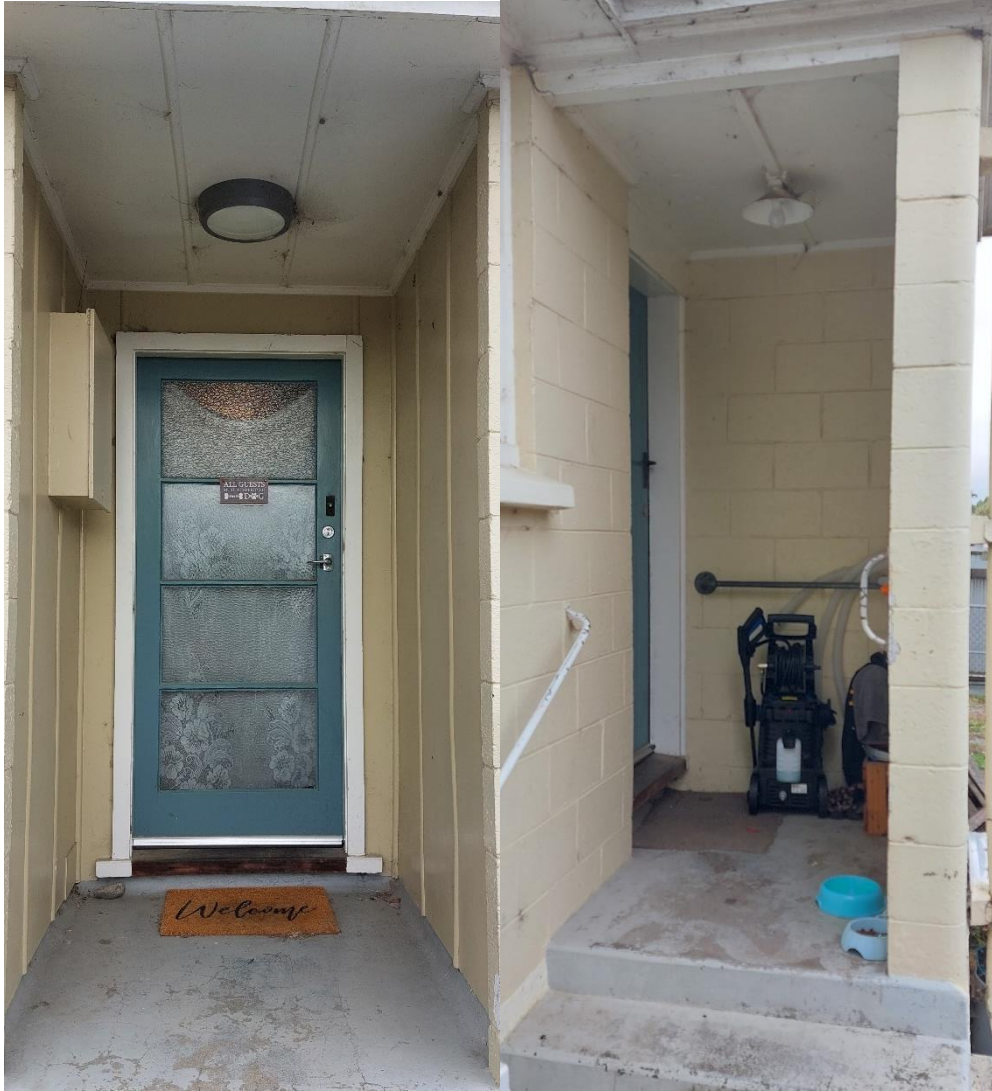
Photograph B25 (left) and B26 (right): Dwelling's front and rear entryways, respectively; PACM ceiling and walls at front entrance. PACM ceiling and painted concrete block walls at rear entrance.
